# **Executive Summary**

Calhoun's Solution

This sturdy 72 x 100 HT Series fabric structure salt

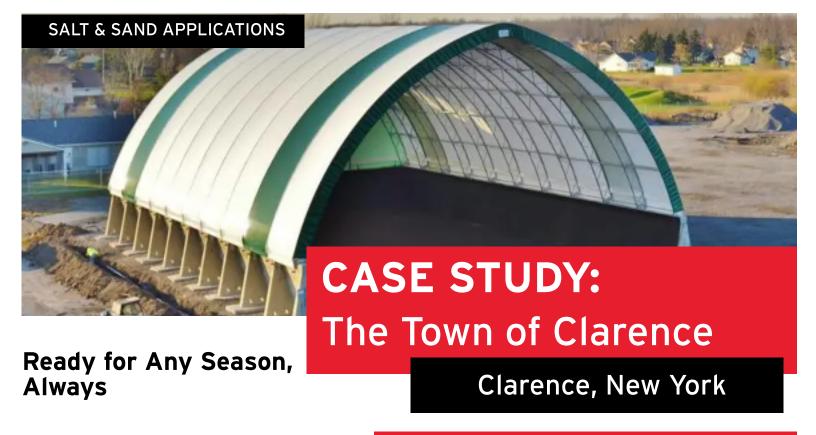
Aging salt storage facilities run the risk of structural failure and may no longer provide adequate space for salt deliveries throughout the winter months. The Town of Clarence needed a new facility with plenty of storage space, as well as enough clearance for salt delivery trucks to drive right inside without risk of damaging the structure. Project Profile

#### storage building was built within days and in time for the Additional Information: winter season. The concrete foundation and walls provide
