HOT-DIP GALVANIZATION

HOT-DIP GALVANIZATION INCREASES THE LIFE USE OF YOUR FABRIC BUILDING

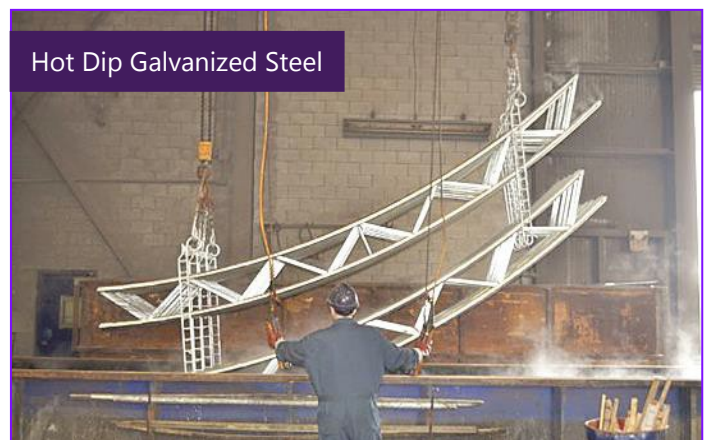
Hot Dip Galvanized Steel

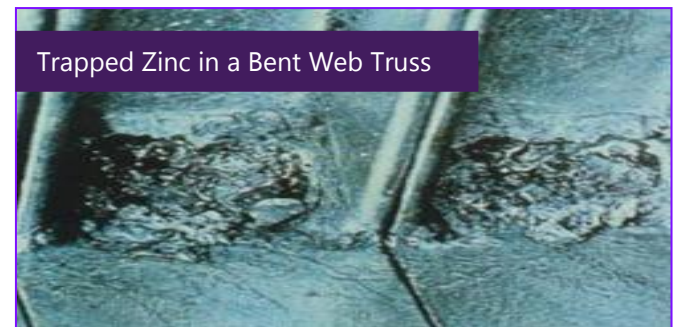
To ensure HDG sectional steel, such as trusses, meet the highest standard, vent holes must be reinforced to parts, pieces, end plates, and similar features. Open web trusses meet these standards. As the components are immersed in molten zinc on an angle, vent holes must be arranged so the zinc can run in and out freely of corners and angles. Otherwise, zinc may get trapped in these 'pockets' resulting in defects, as is common in bent web trusses. This causes buckling and corrosion from the inside of the steel trusses, resulting in a weaker overall fabric building. Be sure that the fabric structure company you choose aerates all corners of the welding points so the zinc penetrates and coats the steel while avoiding pockets for zinc to trap.

Trapped Zinc in a Bent Web Truss
